## Case Report

# Prosthetic rehabilitation of the anterior esthetic zone with implant supported FDP and Laminate veneer: A case report

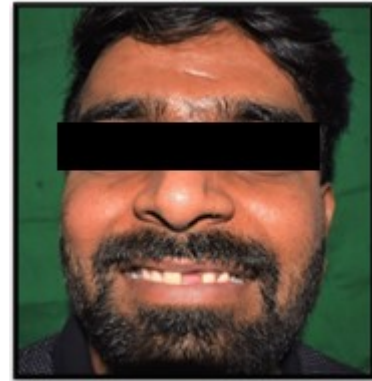
**Fig. 1:** Pre-operative frontal view

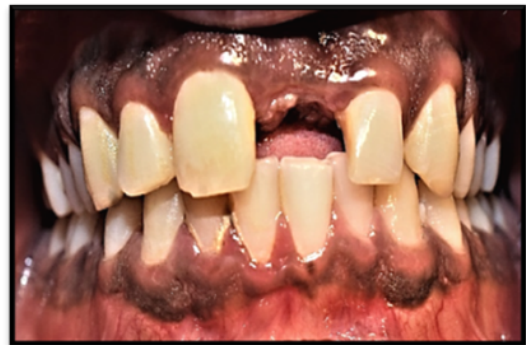
An extensive intra oral examination showed missing 21 (Fig.1, Fig.2, Fig.3) and the periodontal condition was good and oral hygiene was well maintained. He was evaluated medically, radiographically (OPG and CBCT) to assess the current health status and to rule out any underlying pathologies and to evaluate the quality of the bone. The patient was explained about all the treatment options available and finalized with implant placement followed by prosthetic rehabilitation

**Fig. 2:** Frontal View- Missing 21

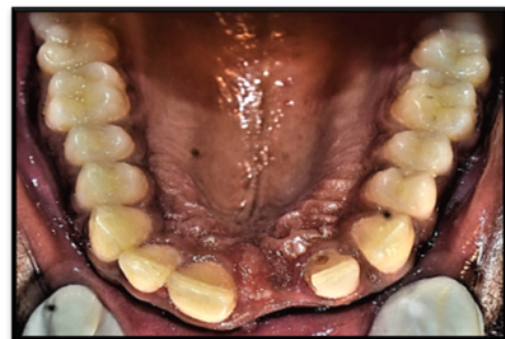
**Fig. 3:** Occlusal View

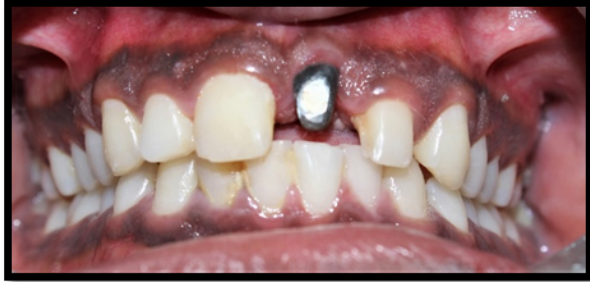
**Fig. 4:** ADIN 15-degree abutment in place w.r.t 21 and the incisal lapping design w.r.t 22

After 3 months second stage surgery was done and healing cap was placed (ADIN). Emergence profile was checked after 2 weeks. The mesio-distal distance of the missing space was slightly excess to compensate only with the implant supported crown and expected an aesthetic failure. The patient was informed and the incisal lapping design with an equigingival finish line was prepared on the left lateral incisor for porcelain veneer (Fig 4). A 15-degree ADIN abutment was selected, the seating of the abutment was checked and torqued with a ratchet (Fig 4). The occlusal clearance of the abutment was checked and a close tray impression was made using poly vinyl siloxane impression material (Aquasil, DENTSPLY, Germany).

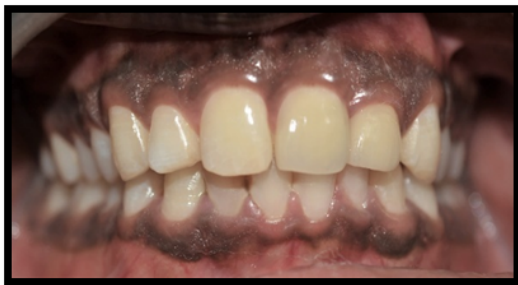
**Fig. 5:** Intra oral view-Final restoration

After 4 days, the final restorations were fabricated (Fig.5). The proximal contacts and the occlusion were checked and the implant supported crown w.r.t 21 was then cemented using zinc oxide eugenol temporary

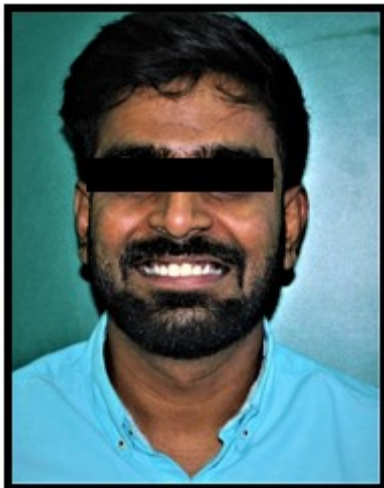
**Fig. 6:** Post-operative frontal view

cement for easy retrieval in the future. The universal bonding protocol was followed for the cementation of laminate w.r.t 22. Post cementation oral hygiene instructions were given and advised recall after 3 months. The patient was happy with the aesthetics as well as the functional outcome which boosted his self-confidence. (Fig.6)
