Case Report

Zirconia Veneers In Fluorosis Patient: Case Report

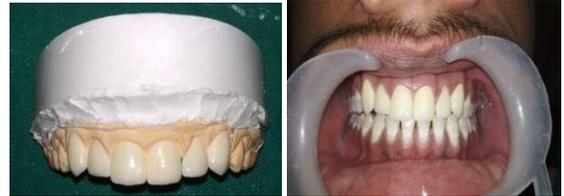
An 18 year old male patient reported to Department of Prosthodontics at Dashmesh Dental College, Faridkot with a chief complaint of compromised esthetics due to Fluorosis (figure 1). On examination, it was found that patient had generalized fluorosis. The brownish spots were found to involve more than two third of all permanent teeth. Mild spacing also find in the maxillary and mandibular anterior teeth. The patient

had Angle's Class I occlusion. Good oral hygiene was maintained by the patient. There were no carries or bone loss found and the patient had teeth of shade B2. Following the examination, diagnosis of generalized moderate Grade III Fluorosis was made based on history, clinical findings and Dean's index (figure 2 & 3). The patient was explained all the treatment options. Considering patient's age, profession, interests, awareness and oral health, zirconia veneers were chosen to esthetically rehabilitate all the maxillary anterior teeth, i.e. maxillary central and lateral incisors and canines.

In the next appointment, all the teeth involved were reduced 0.3mm approximately from facial and incisal aspects (figure 4 & 5). The long chamfer finish line was given. Following the reduction, secondary impression was made using addition polyvinyl siloxane (Gcflexceed putty with Gc light body) using double mix single stage technique (figure 6). The provisional restoration was given using tooth colored auto polymerized acrylic resin. The secondary case was poured using type IV dental stone.
