Case Report

Zirconia Veneers In Fluorosis Patient: Case Report

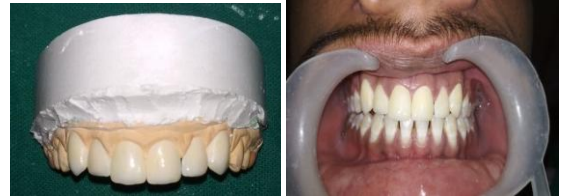
An 18 year old male patient reported to Department of Prosthodontics at Dashmesh Dental College, Faridkot with a chief complaint of compromised esthetics due to Fluorosis (figure 1). On examination, it was found that patient had generalized fluorosis. The brownish spots were found to involve more than two third of all permanent teeth. Mild spacing also find in the maxillary and mandibular anterior teeth. The patient

had Angle's Class I occlusion. Good oral hygiene was maintained by the patient. There were no carries or bone loss found and the patient had teeth of shade B2. Following the examination, diagnosis of generalized moderate Grade III Fluorosis was made based on history, clinical findings and Dean's index (figure 2 & 3). The patient was explained all the treatment options. Considering patient's age, profession, interests, awareness and oral health, zirconia veneers were chosen to esthetically rehabilitate all the maxillary anterior teeth, i.e. maxillary central and lateral incisors and canines.

In the next appointment, all the teeth involved were reduced 0.3mm approximately from facial and incisal aspects (figure 4 & 5). The long chamfer finish line was given. Following the reduction, secondary impression was made using addition polyvinyl siloxane (Gcflexceed putty with Gc light body) using double mix single stage technique (figure 6). The provisional restoration was given using tooth colored auto polymerized acrylic resin. The secondary case was poured using type IV dental stone.

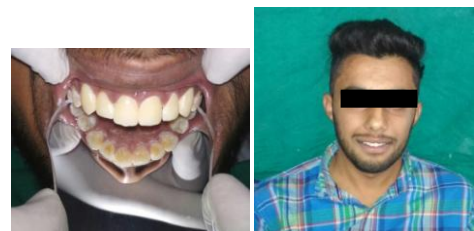
Secondary casts were send to lab for final zirconia veneers fabrication by hard milling technique using Vita in ceram shade 3d master 1M1 (figure 7). The zirconia veneers were delivered in the final appointment by luting using dual cure resin following the manufacturer's instructions and the patient was given post-operative instructions (figure 7 to 10). The patient was extremely satisfied with the prosthesis.
